MARINE INVESTIGATION REPORT

M03N0050

FIRE ON VEHICLE DECK

JOSEPH AND CLARA SMALLWOOD

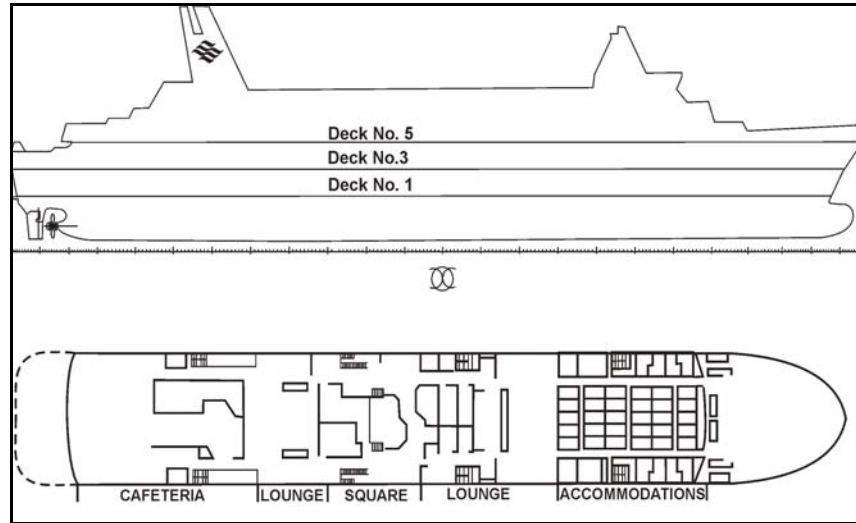
Figure 2. Deck 5

At approximately 2330, the master contacted the senior chief steward (SCS) and was advised that there was smoke in the forward section of deck 5. As a result, all passengers were directed to muster in the cafeteria by means of a PA announcement. At 2340, a second PA announcement requesting all passengers to muster in the cafeteria was made. Shortly thereafter, the master contacted the SCS with the procedure to be followed for evacuating passengers once they arrived at Port aux Basques.
